REPORT OF THE COMMISSION
ON THE RENOVATION
OF THE EXECUTIVE MANSION

REPORT OF THE COMMISSION ON THE RENOVATION OF THE EXECUTIVE MANSION

Compiled under Direction of the Commission by
Edwin Bateman Morris

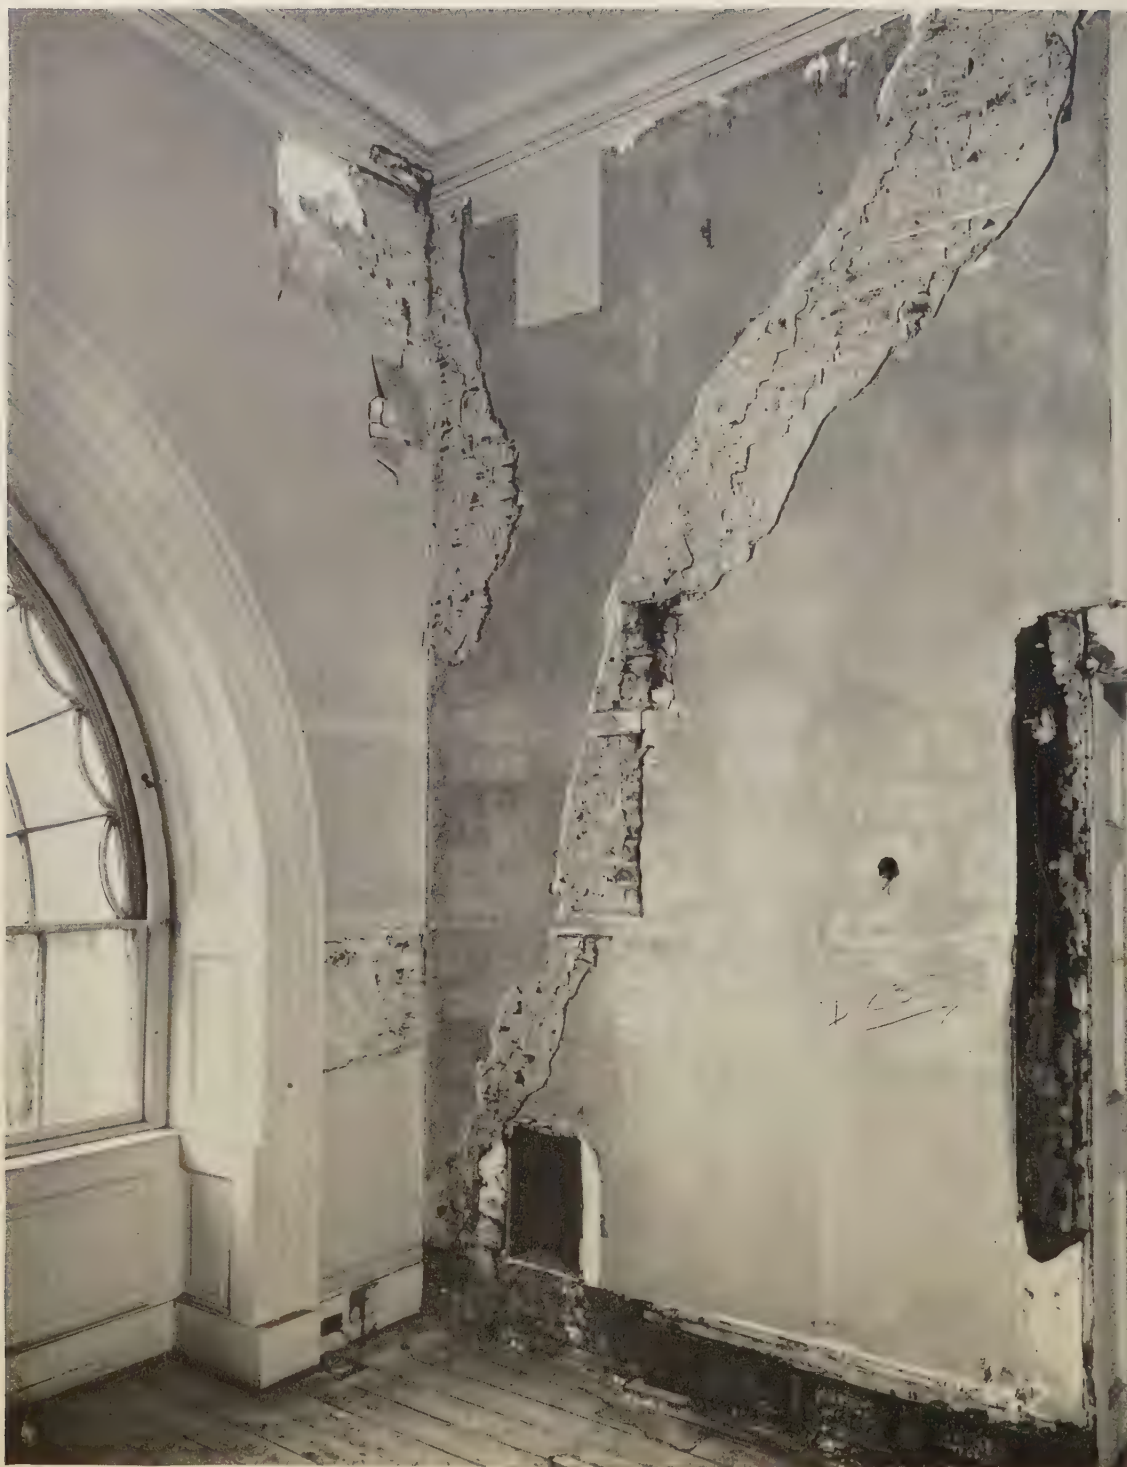
Cracks in the Northwest Corner and in the North Brick Wall in the West Sitting Room, on the Second Floor, as revealed in investigation prior to the Renovation

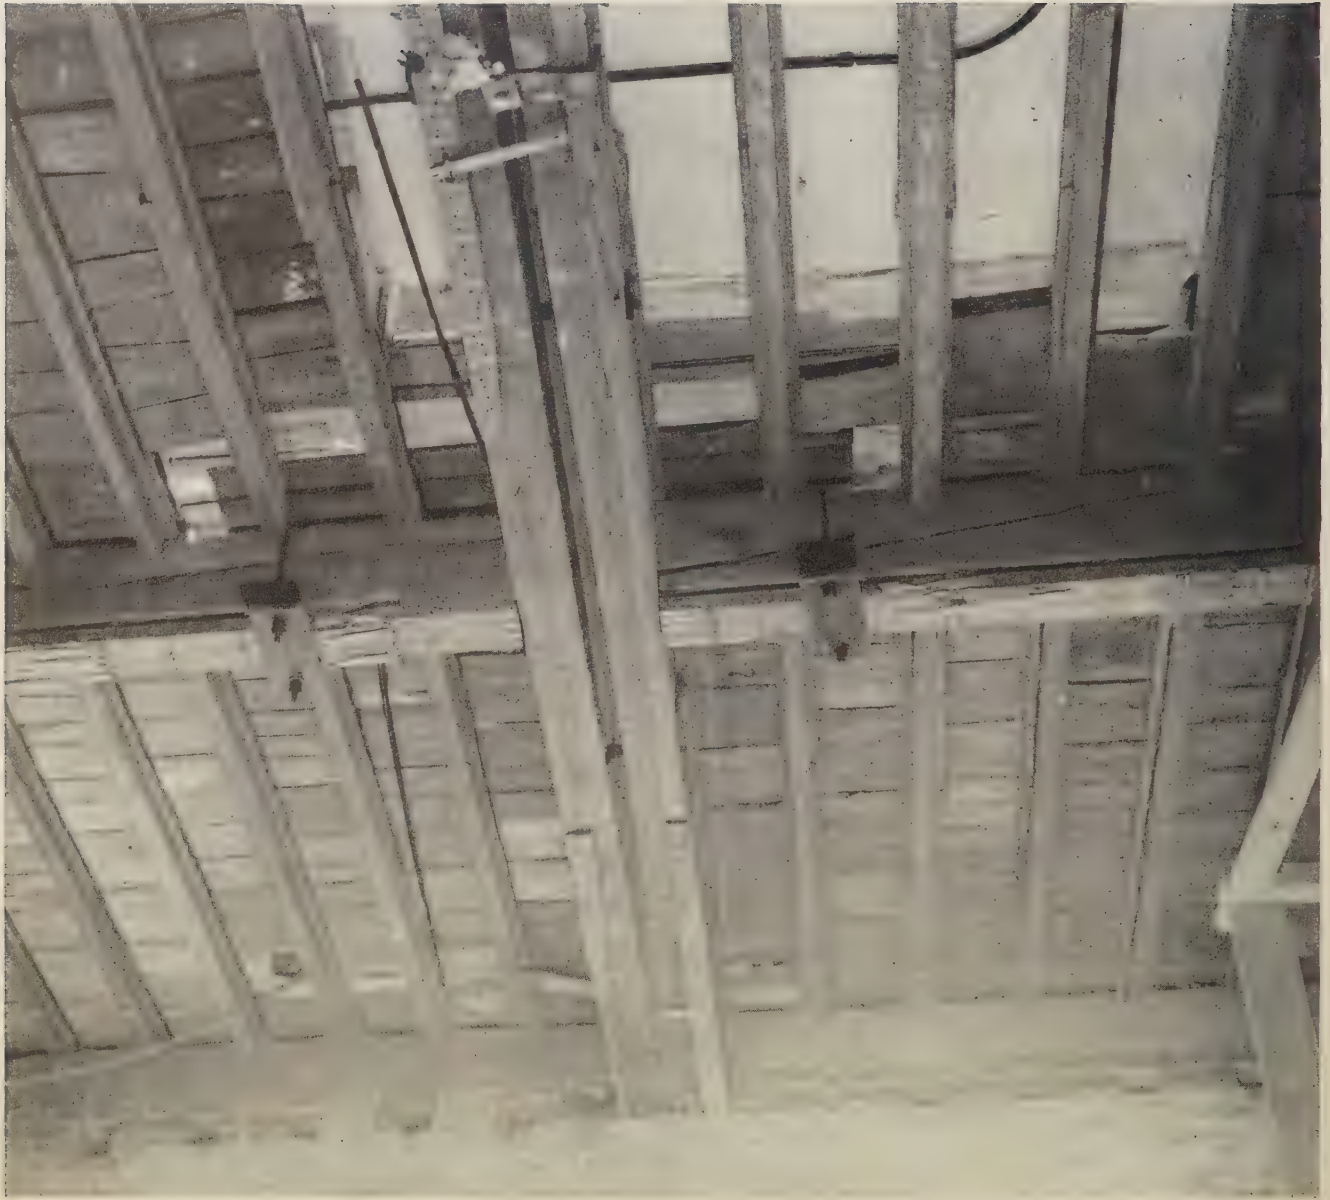
Split in Beam under Room Miss Margaret Truman Occupied as Sitting Room.
Break was the Result of Cutting away Beam at Bearing

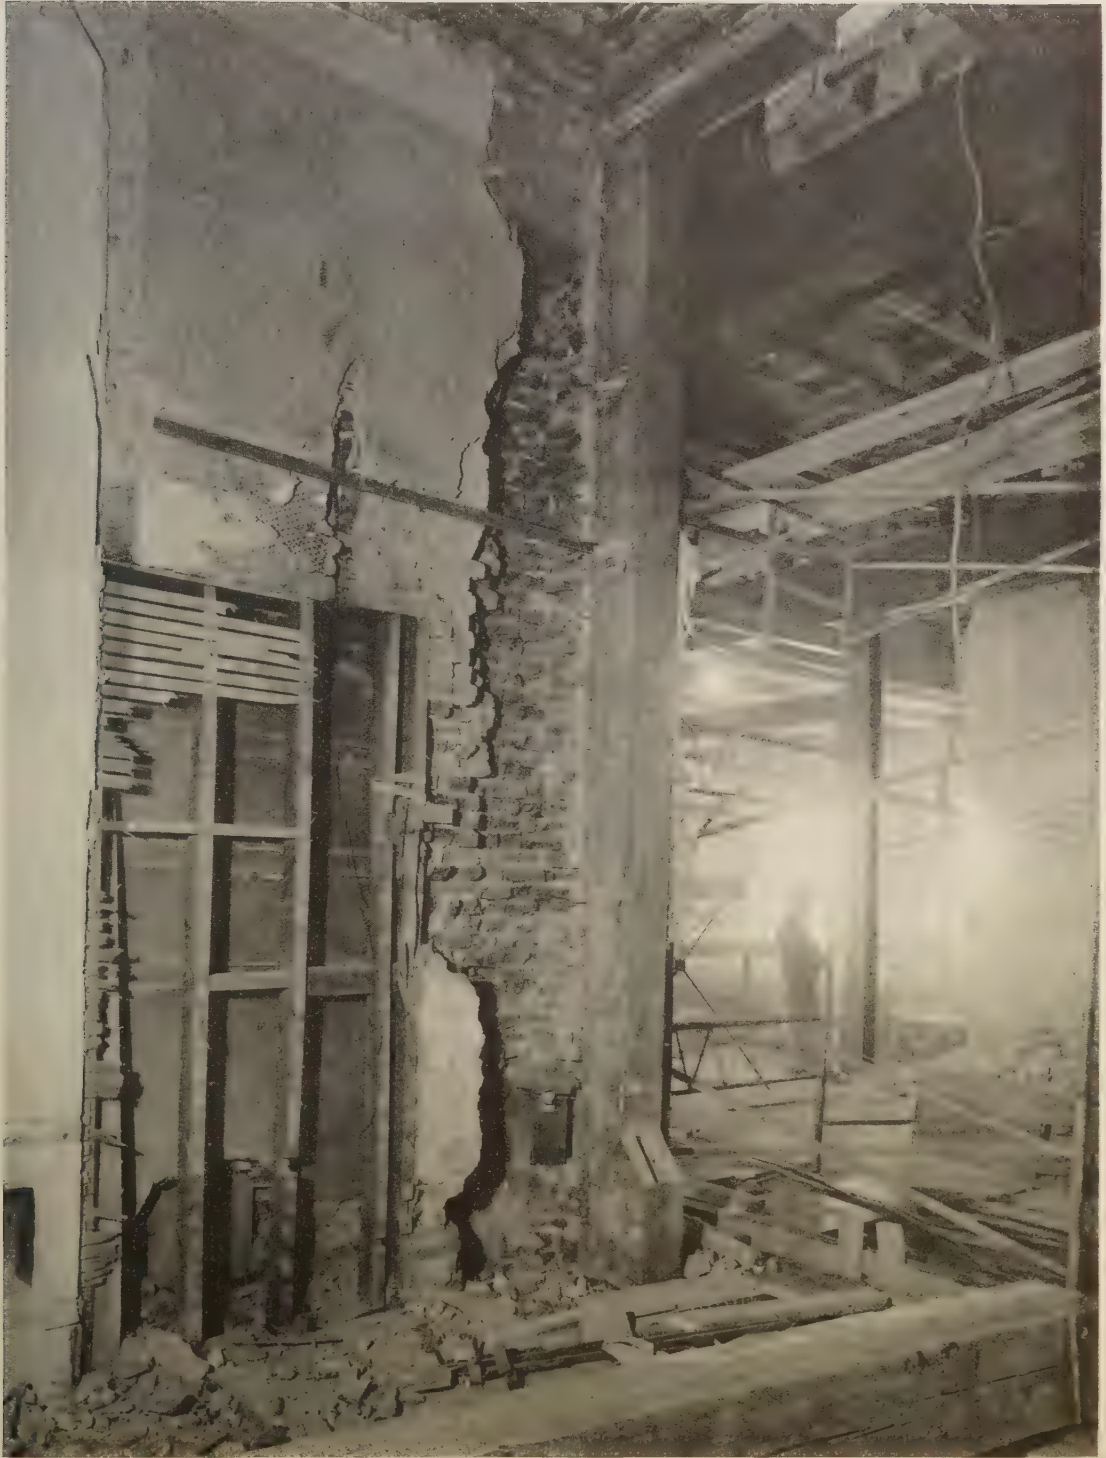
Main Support at Top of Main Stair, Second Floor, under Bearing for T₄ Truss

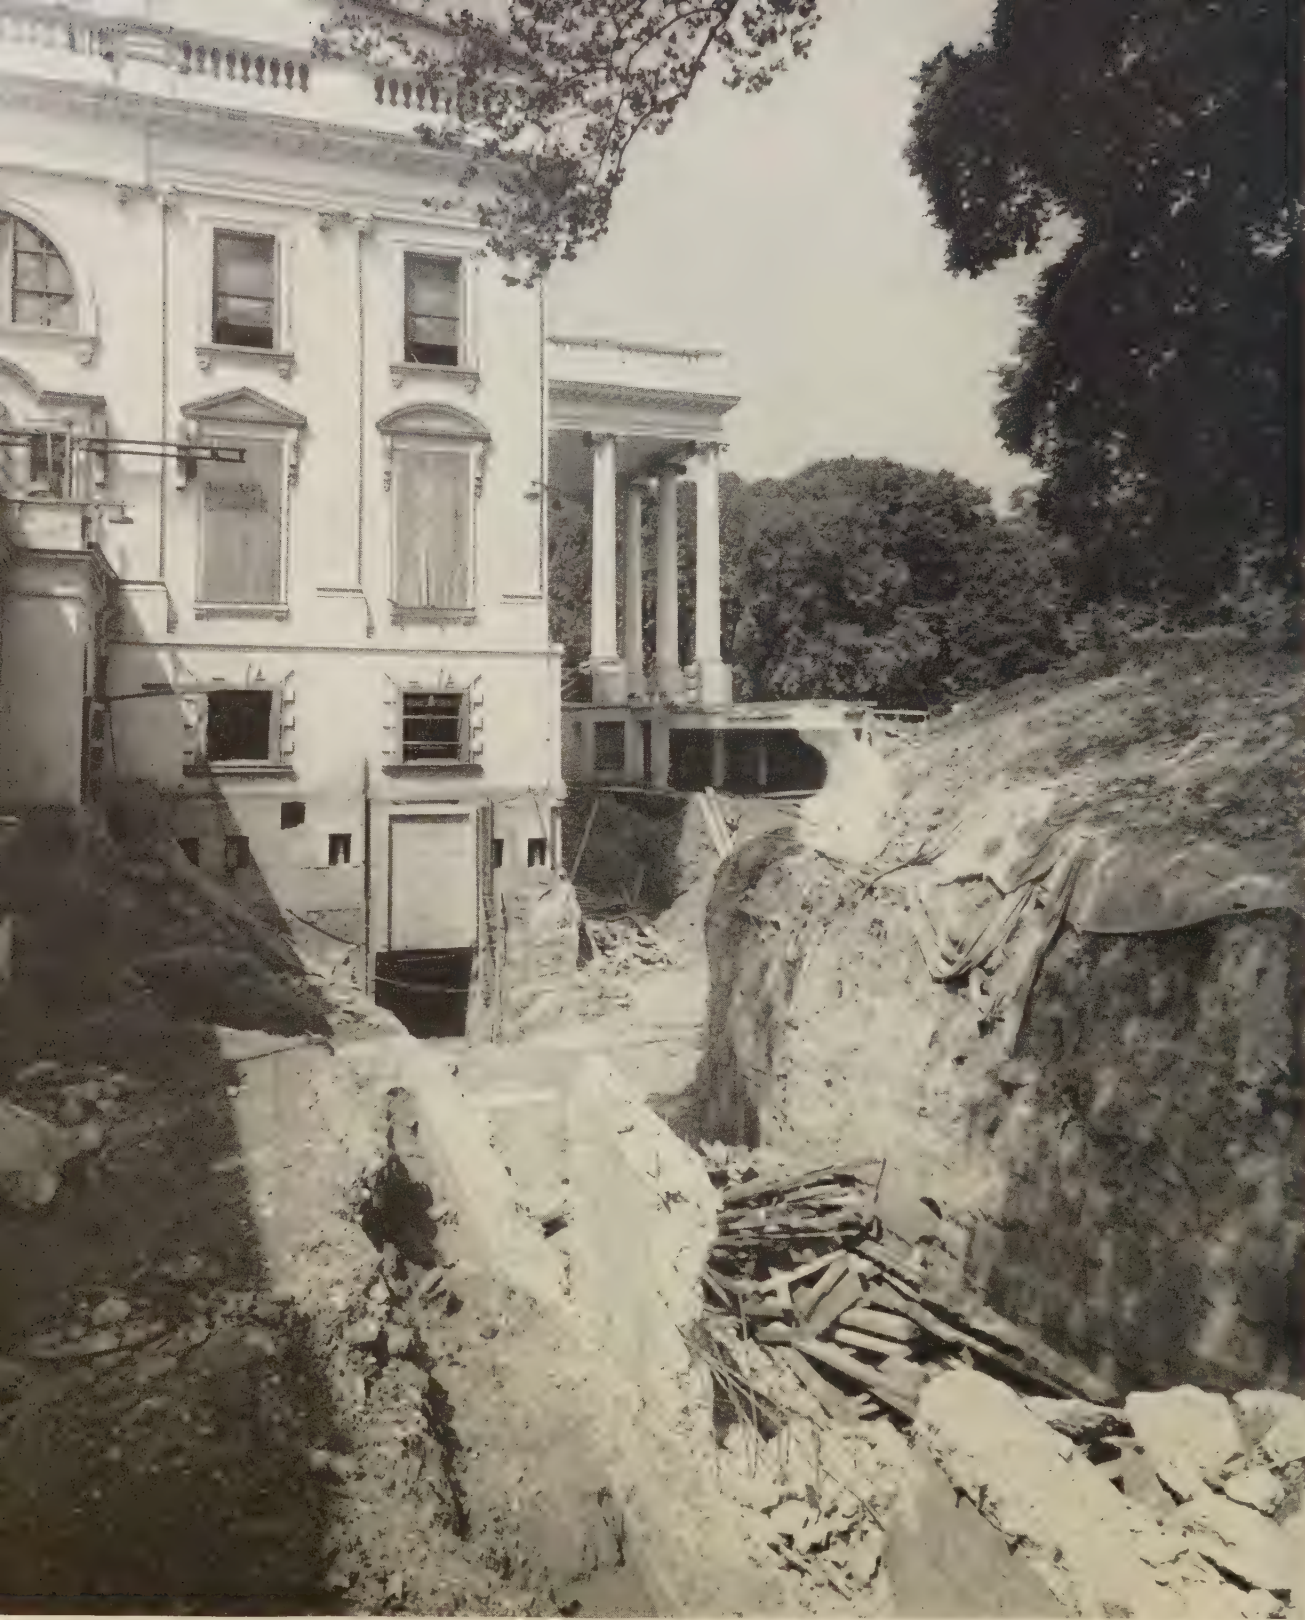
Construction and Excavation at Northeast Corner

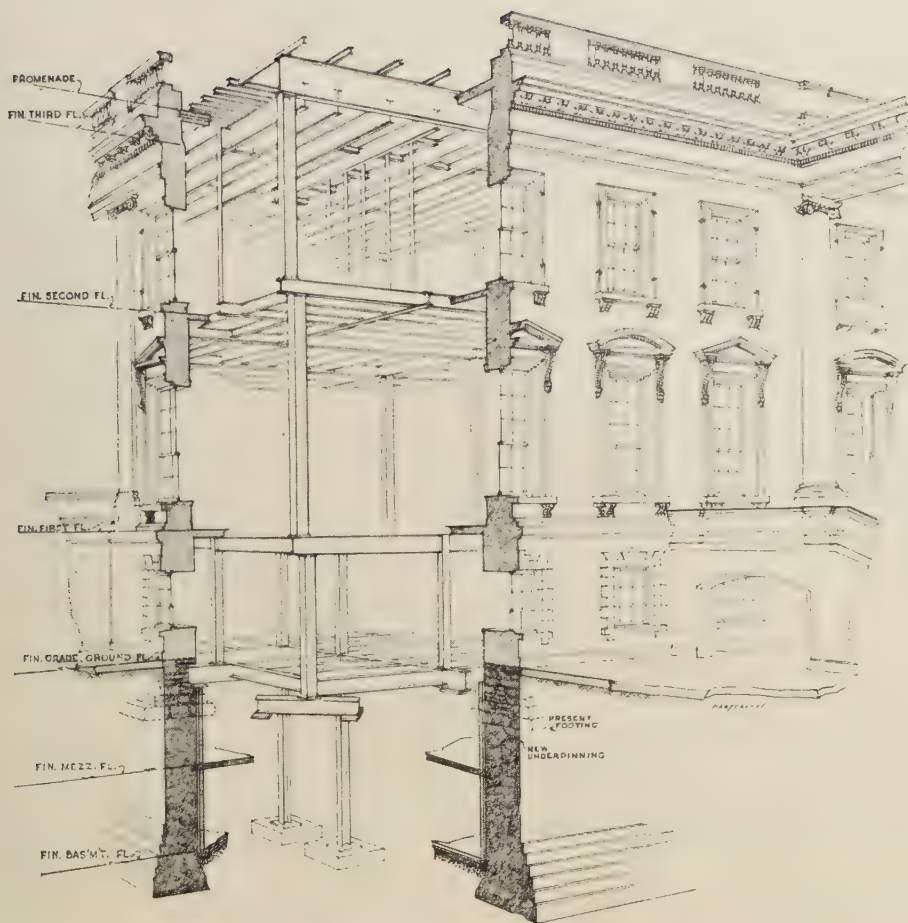
Diagram Showing Wall Underpinning and New Steel Construction

It was necessary, in conformity with the decision to preserve the existing exterior walls, to underpin these walls with concrete piers having footings at varying depths of 24 to 27 feet below the ground level

at the front of the building, where bearing was obtained upon a sand and gravel strata, considered to be much superior to the clay upon which the walls formerly rested.

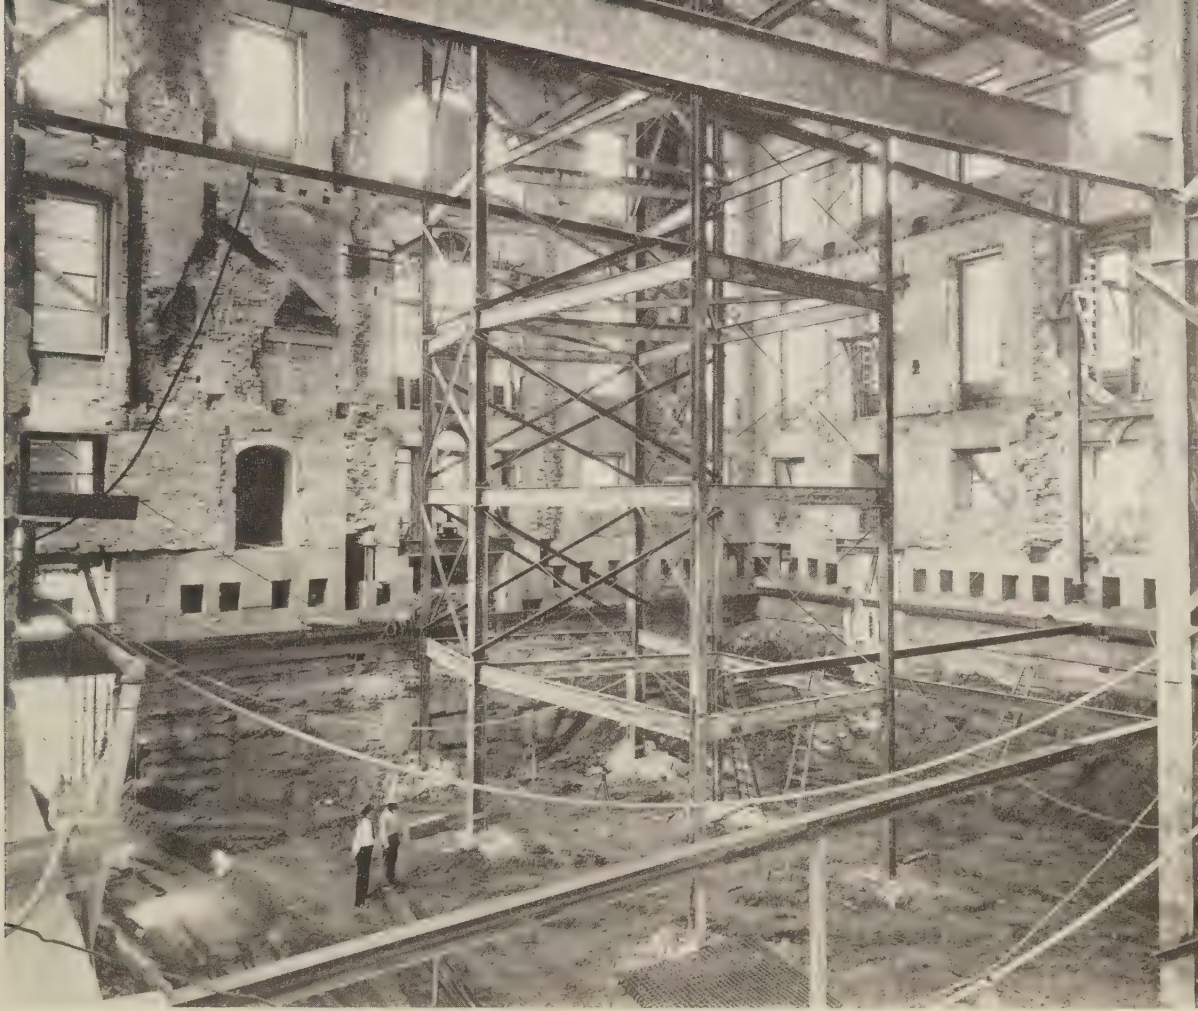
Permanent Steel and Temporary Bracing
in Interior of White House

a new supporting structural steel frame was erected on these footings within the existing masonry walls of the building, thus changing it from a wall bearing construction to a modern steel frame. For the most part the columns at the walls were to run within or close to the walls, but in a few cases the walls were cut back to receive the columns.

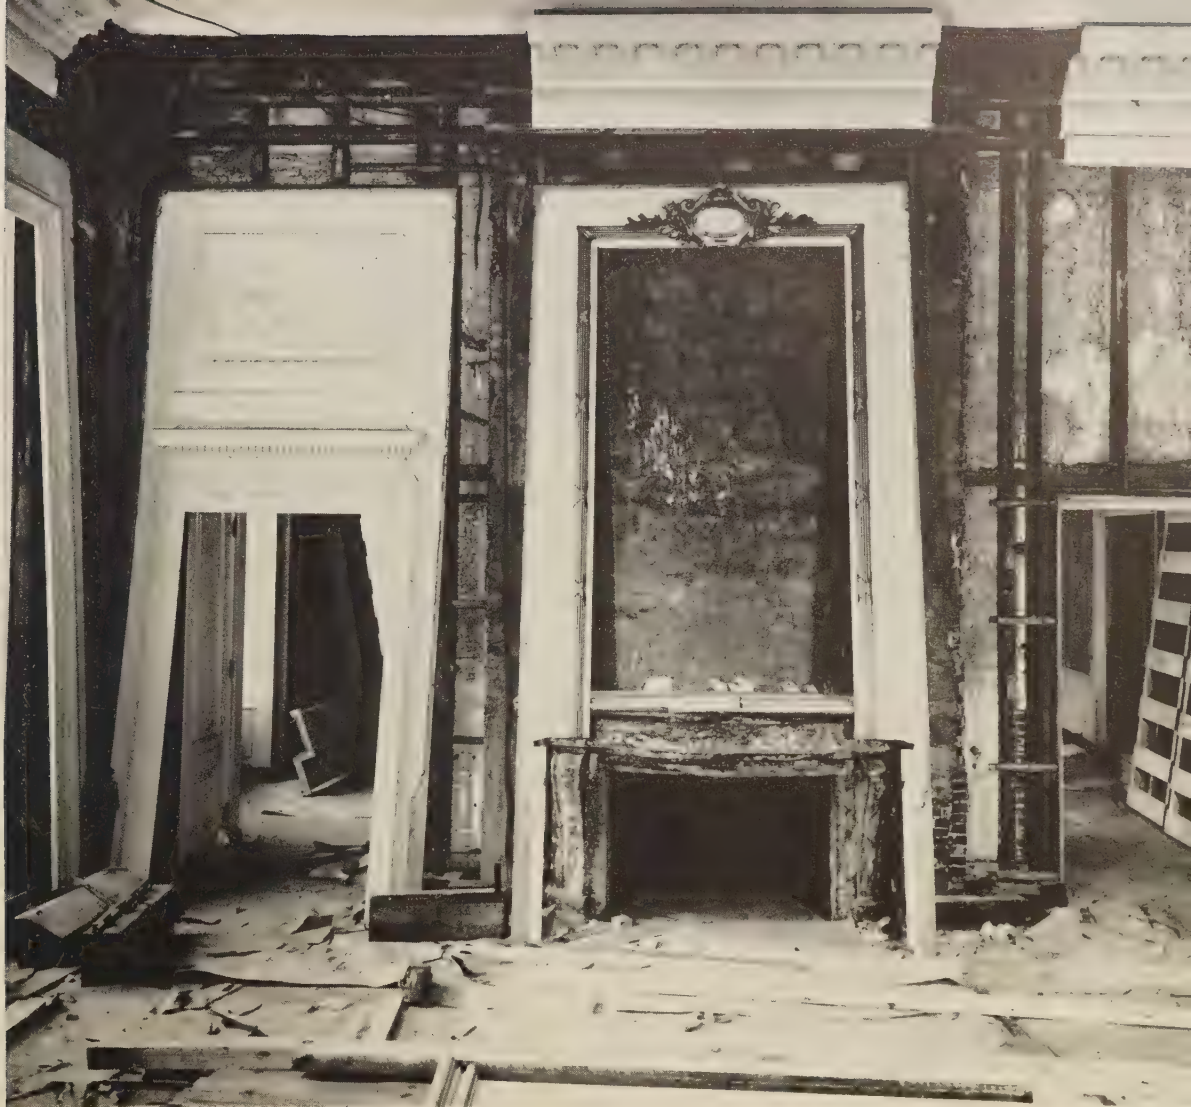
Southwest Corner of East Room Showing Careful Removal of Materials
